**DAM SAFETY INSPECTION  
REPORT**

**DAN RIVER STEAM STATION  
ROCKINGHAM COUNTY,  
NORTH CAROLINA**

**PAUL C. RIZZO ASSOCIATES, INC.  
101 WESTPARK BOULEVARD, SUITE B  
COLUMBIA, SOUTH CAROLINA USA 29210**

**PROJECT NO. 09-4157  
JULY 2009**

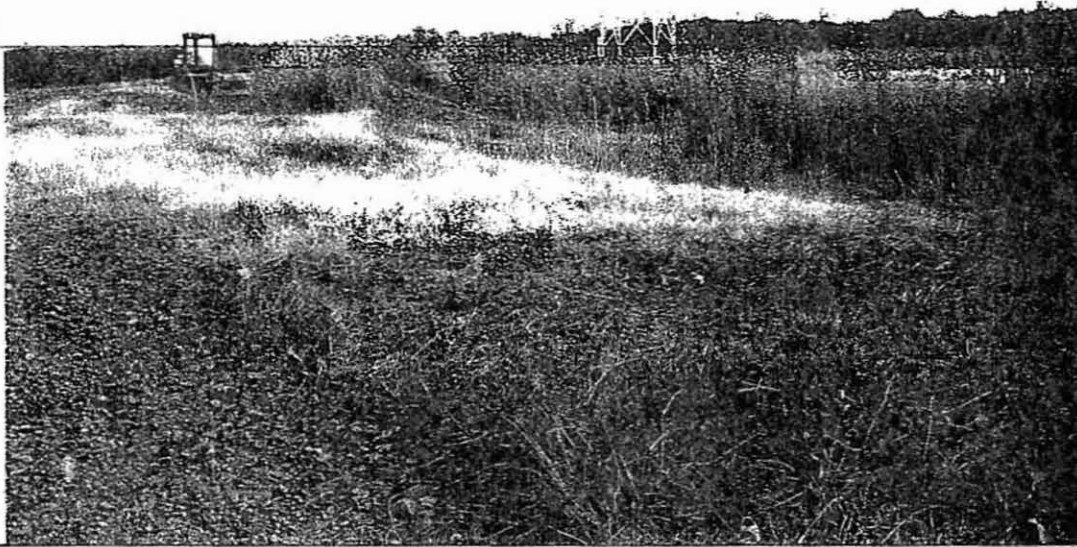
**Photograph 5**

Primary ash basin  
discharge tower

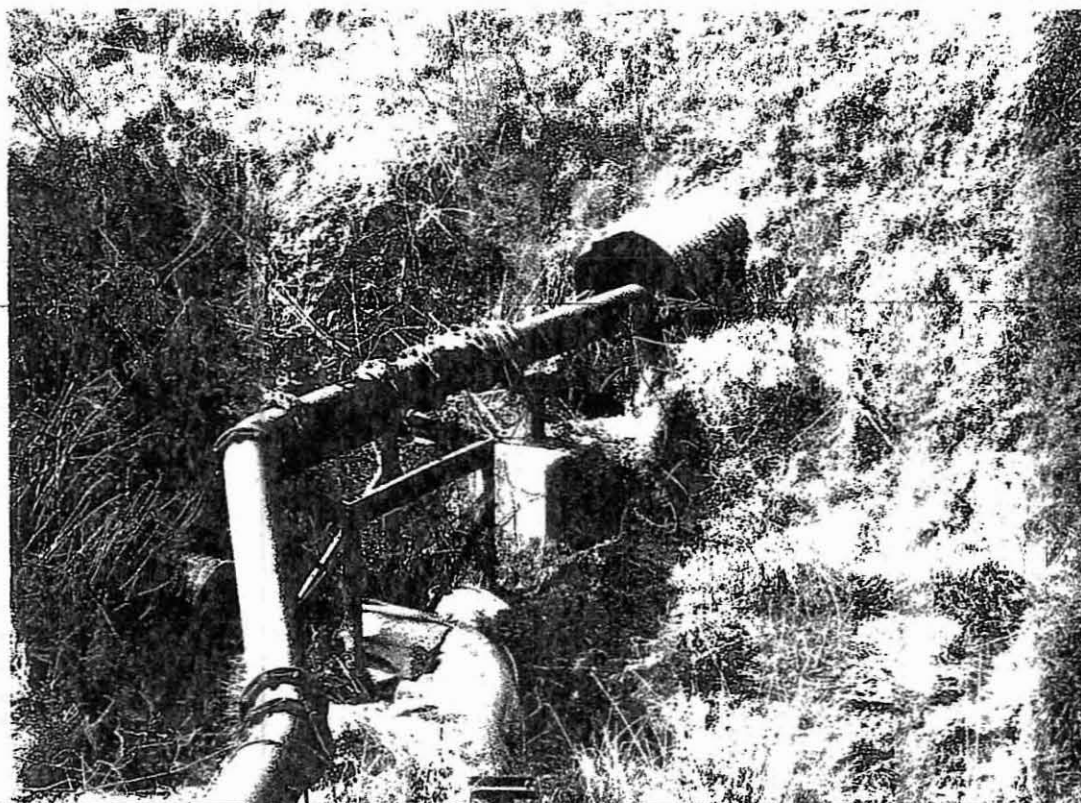
**Photograph 15**

Valley facing west.  
Piping may have been  
realigned at bottom of  
picture since 2001.

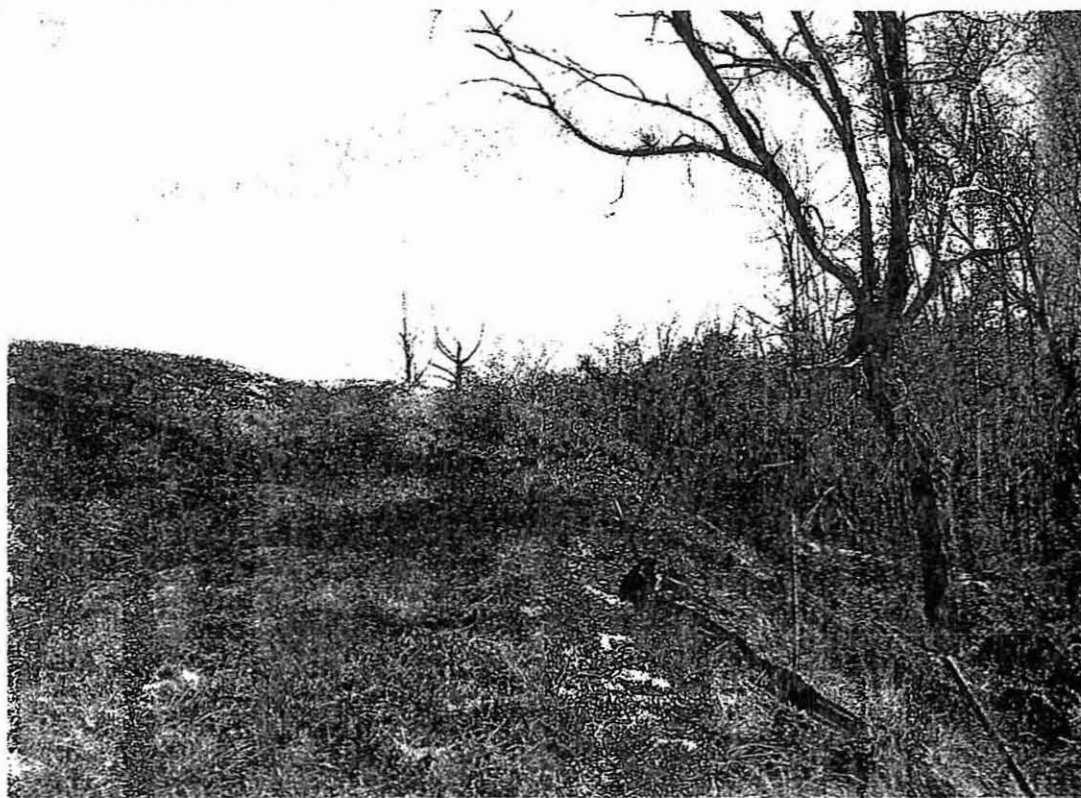
**Photograph 16**

Downstream slope of  
southern section of  
primary basin adjacent  
to Dan River. No  
groundhog burrows  
observed in this area.

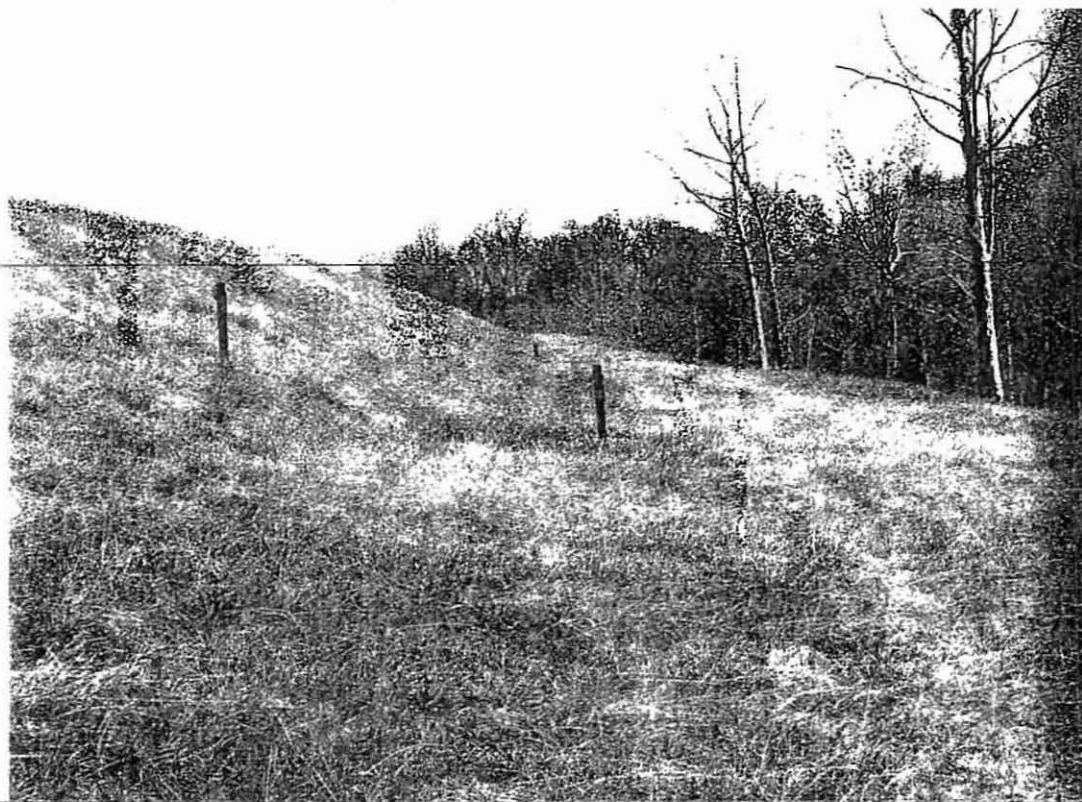
**Photograph 17**

Downstream slope of  
primary basin dike  
adjacent to Dan River.

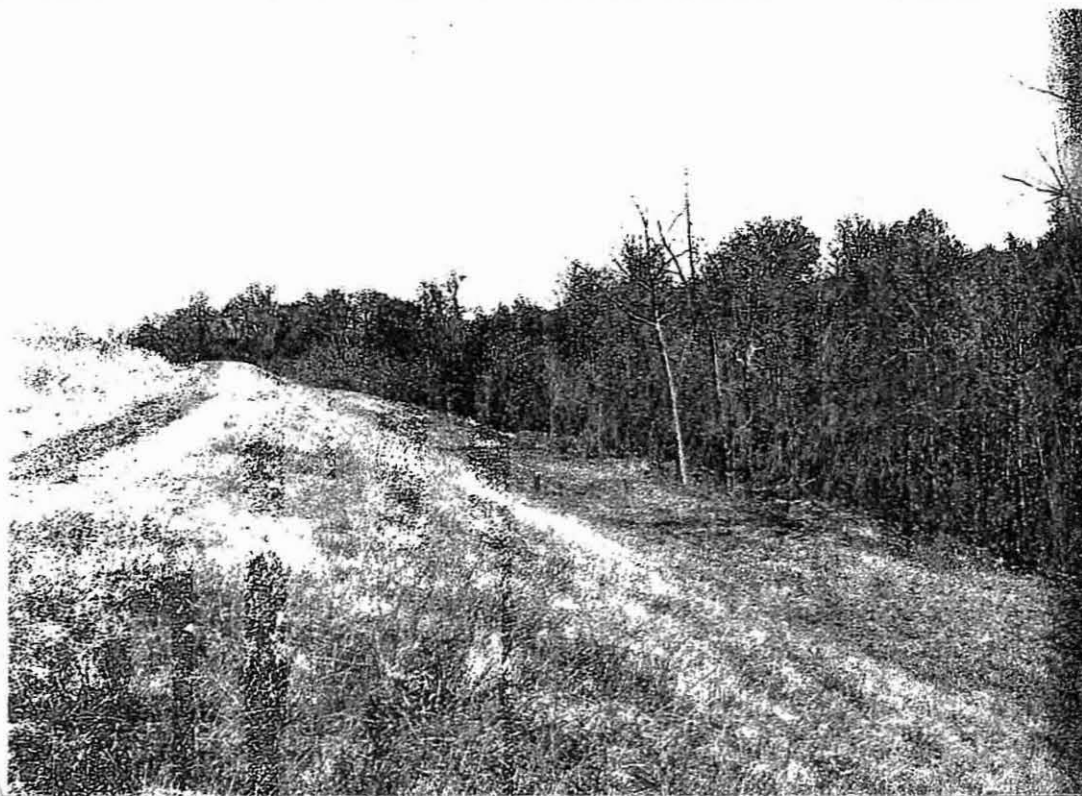
**Photograph 18**

Crest of southern  
embankment for  
primary ash basin.

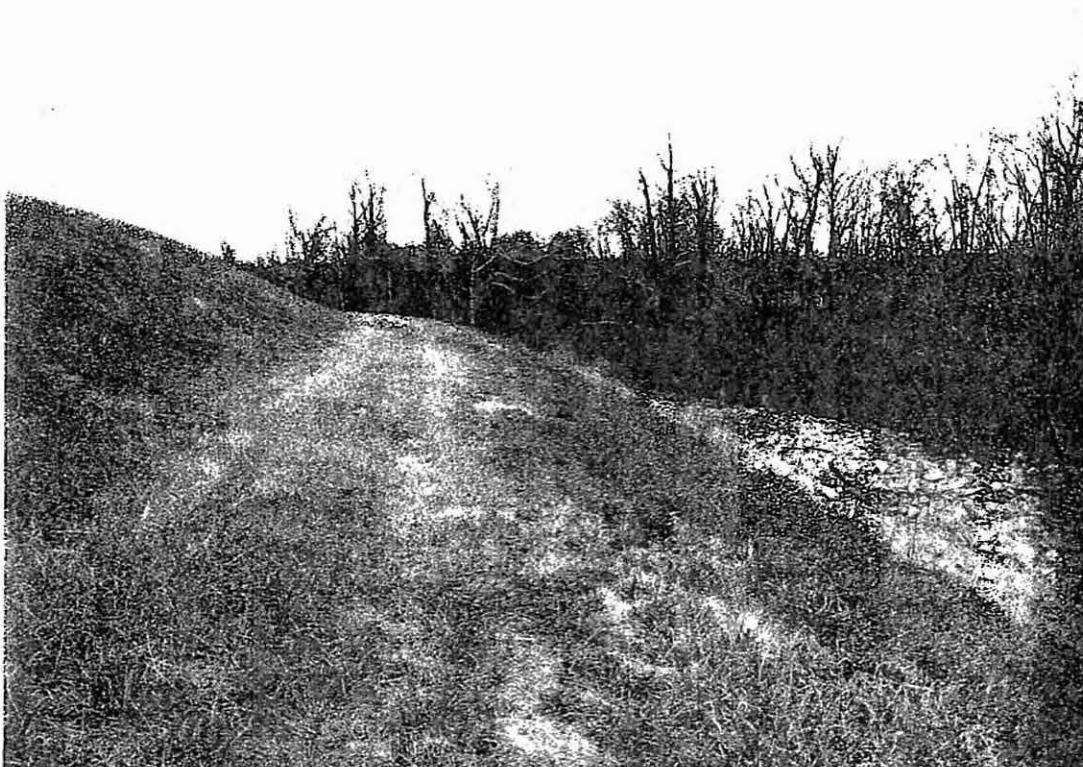
<p data-bbox="1263 1089 1455 1125"><b>Photograph 20</b></p> <p data-bbox="1263 1155 1539 1415">Downstream slope of primary basin facing N-NE adjacent to Dan River. Photographer was standing approximately 900 ft south of piezometer P-2.</p>

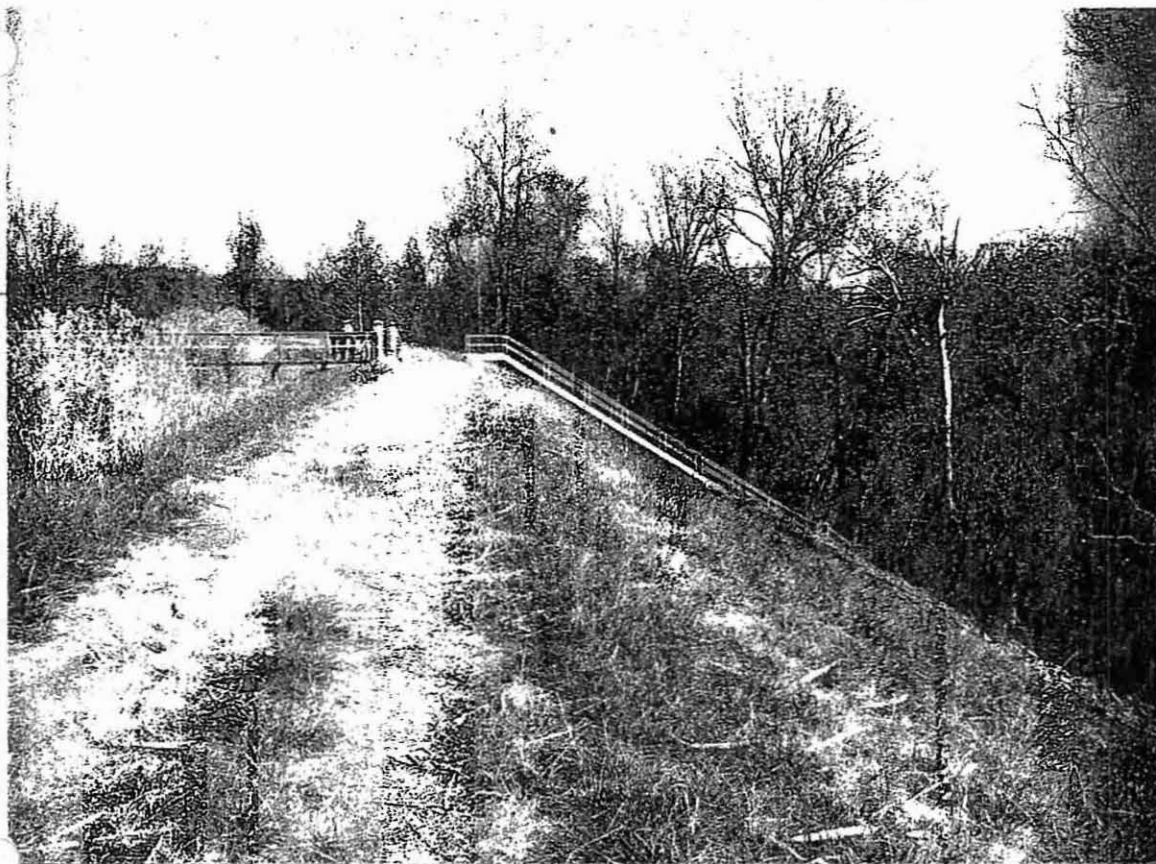
Photograph 23

Crest and downstream slope of secondary basin adjacent to Dan River. Steps leading to secondary basin pipe outfall have been replaced since 2001.

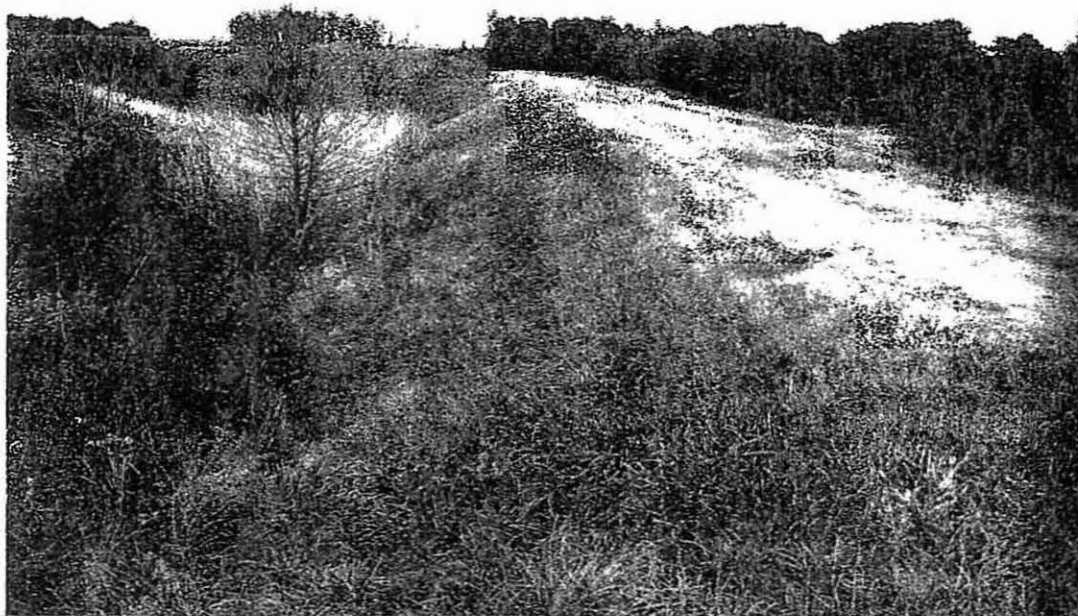
**Photograph 31**

Upstream slope of dry storage basin, E view.
